June 8, 2023

Marshall Fire Investigative Summary and Review

Michael T. Dougherty
District Attorney - 20th Judicial District

Curtis Johnson
Boulder County Sheriff

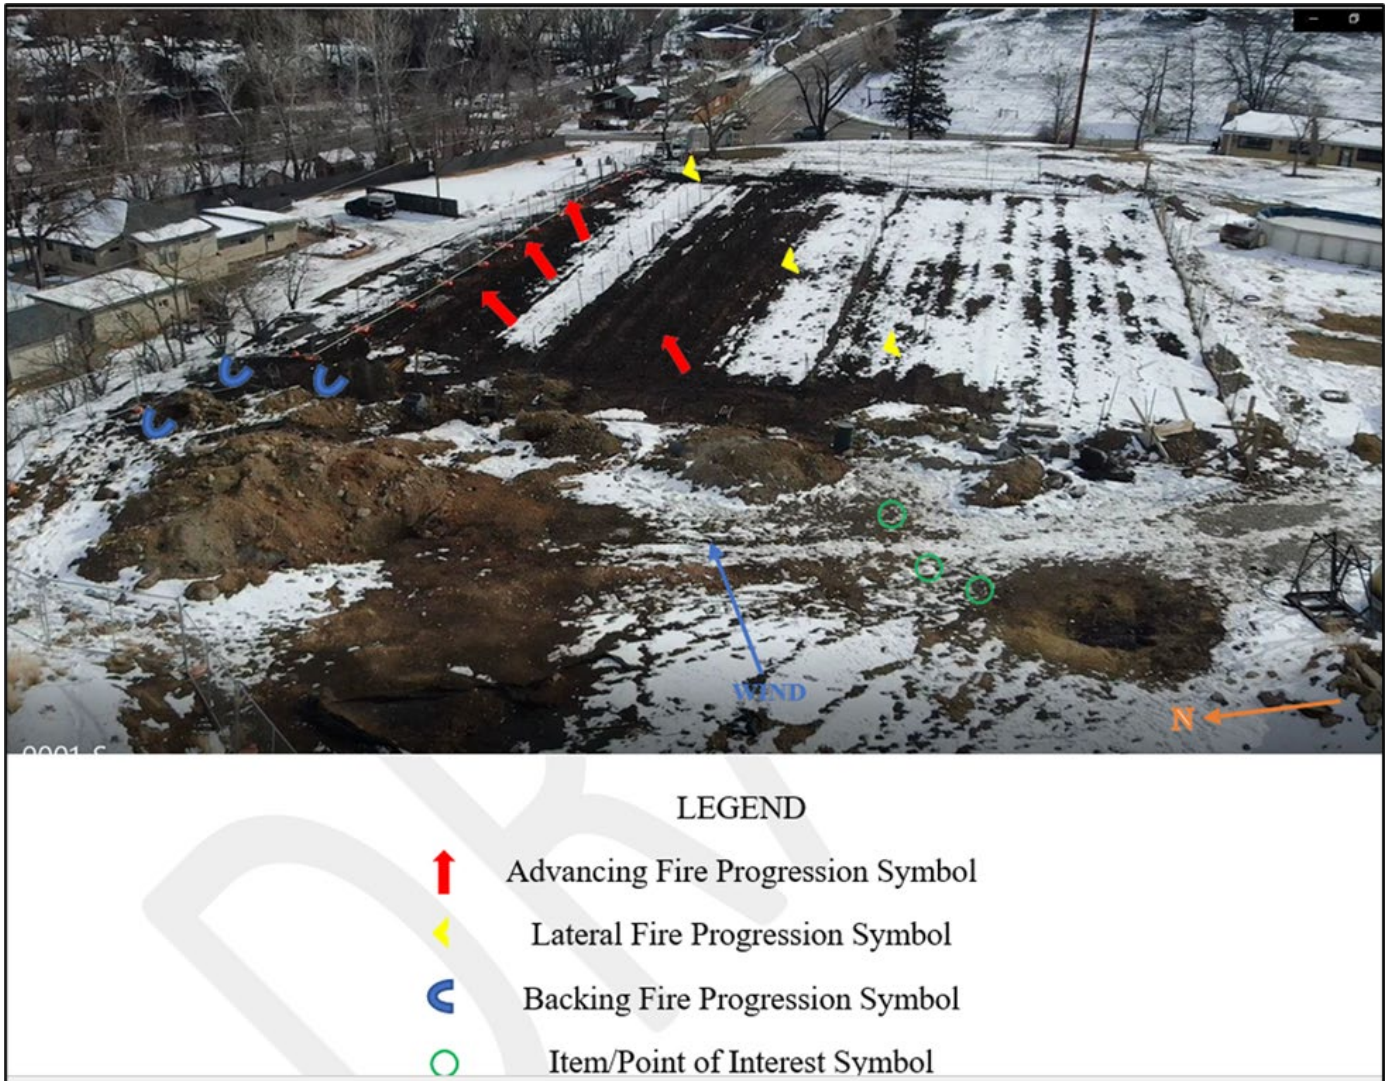
Exhibit 2

The windblown embers landed in dry grassy fuels along the western fence line of a garden area down wind of the debris burn location. The growing fire ignited chipped wooden mulch which covered the garden surface. Burning wooden mulch was blown across and from the garden in the extreme westerly winds. The exact area of ignition was not located due to the ignition source being consistent with the receptive fuels located near the fence line. The amount of disturbance as a result of the fire suppression effort in and near the specific origin area impacted the investigators' ability to identify the exact area of ignition.

(See Exhibit 2.)

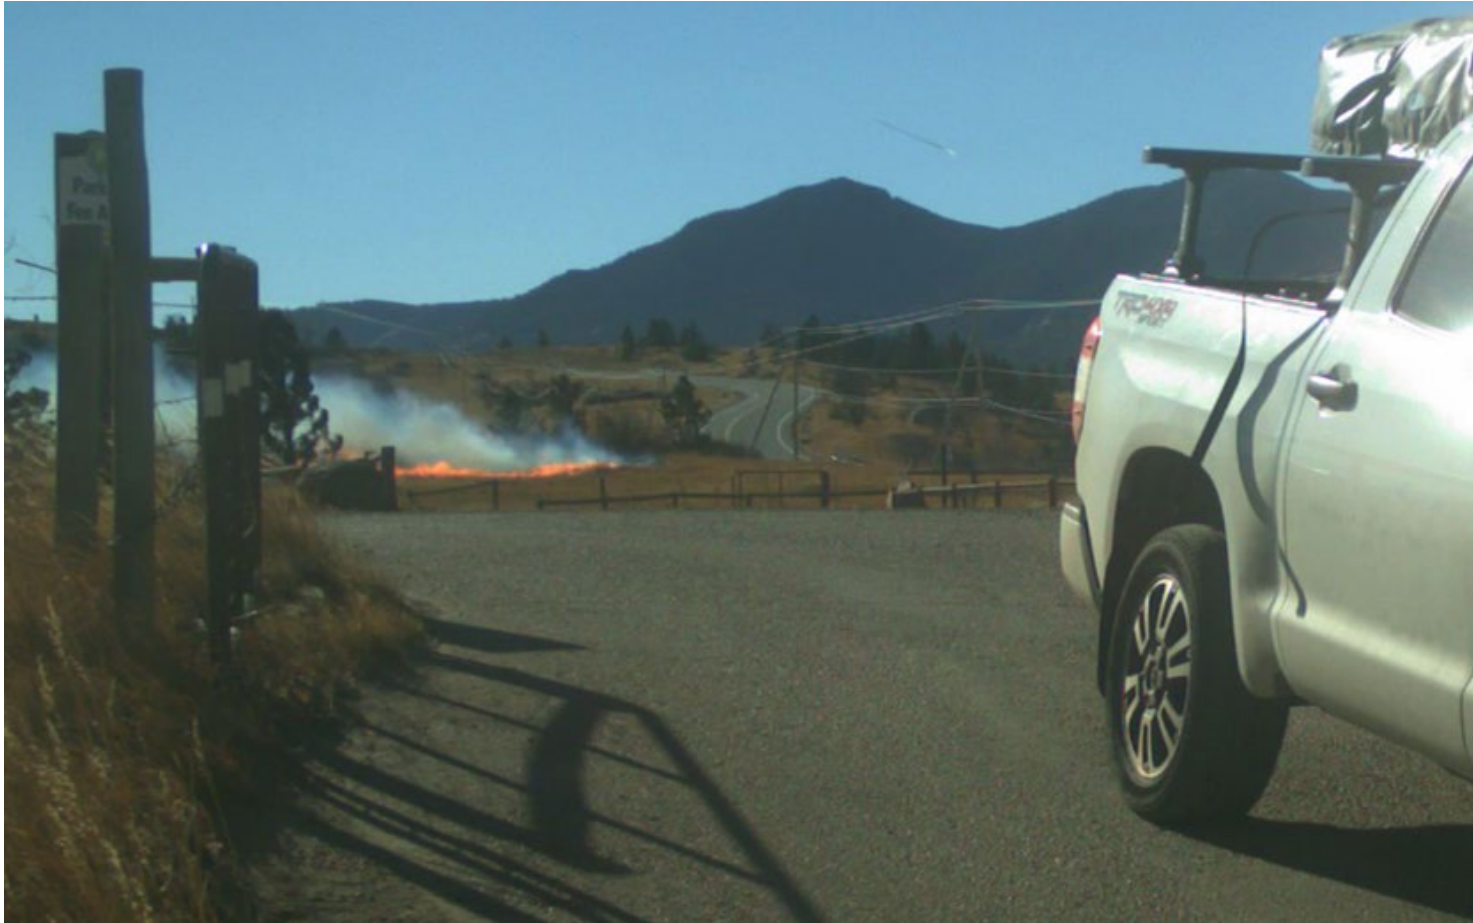
Exhibit 5

During the following days, however, Boulder County Sheriff detectives collected images from a motion-activated trail camera they previously had installed at the Marshall Mesa Trailhead to deter motor vehicle trespasses and thefts. The camera was trained on the entrance to the trailhead parking lot but captured, in the background, a section of the Xcel Energy distribution system that runs along Highway 93. A series of photographs retrieved from this camera showed that, between 10:30 a.m. and 11:10 a.m. on December 30, 2021, the eastern “phase”—one of the three powerlines that run across the top of the power poles along the highway—came unmoored from a crossarm and sagged low enough to contact a support brace. (*See Exhibit 4.*) Subsequent photos showed smoke and flames in an area near the base of the pole from which the line disconnected. (*See Exhibit 5.*) Using photos from the game camera, investigators located other witnesses who had visited the Marshall Mesa Trailhead area during and after the fire. These individuals provided additional photographs and videos, confirming that the powerline detached from its insulator before the Trailhead Fire had ignited.

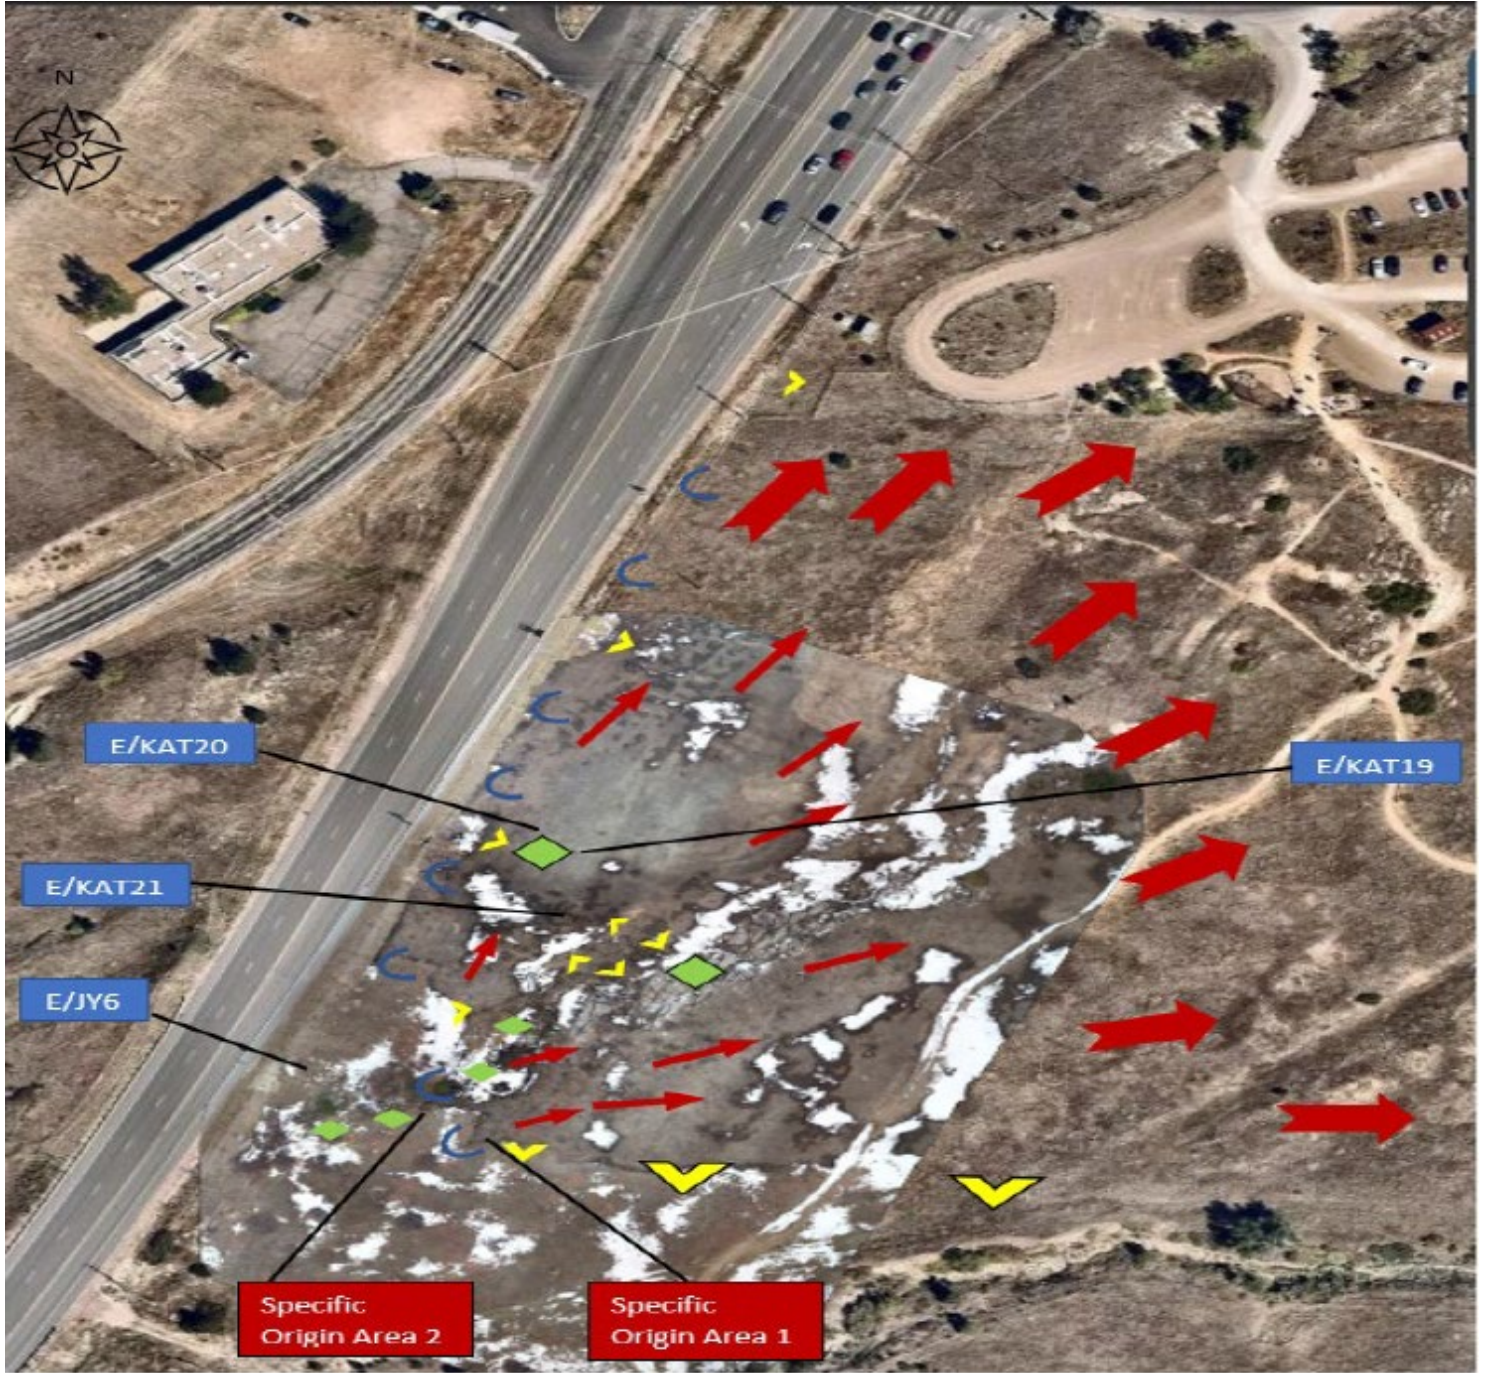
Exhibit 6

Investigators returned to the trailhead on January 14, 2022, to further examine the area near the disconnected powerline. At the base of the pole, agents located discarded aluminum lashing wires like those that would have been used to attach (or re-attach) a powerline to the crossarm. Nearby, investigators located two specific areas in which the Trailhead Fire may have ignited. Those two areas were 79.6 feet and 110.5 feet from the disconnected powerline. (*See Exhibit 6.*)
